AVIATION INVESTIGATION REPORT

A01O0165

IN-FLIGHT BREAK-UP

CESSNA 210L CENTURION C-GPMC
LAKE LAVIEILLE, ALGONQUIN PARK, ONTARIO
18 JUNE 2001

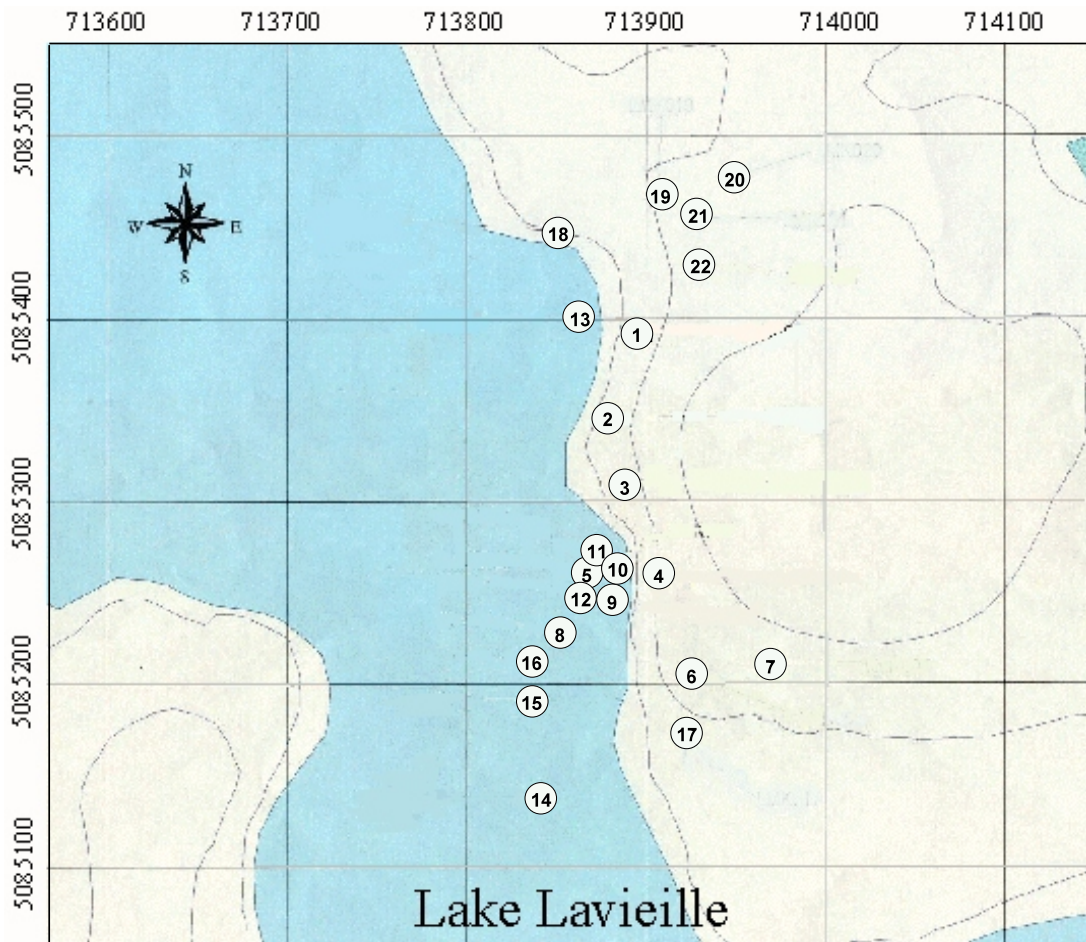
Appendix A—Wreckage Diagram

Notes: Small pieces of aluminum, plastic, plexiglass, and fibreglass were found throughout the entire forested debris field as defined by the landmarks. Although large pieces of wing, stabilizers, and flight controls were found in the water, very little small debris was found in the water, except at the main wreckage site.

The area around 21 and 22 was littered with small debris, that is, small pieces of aluminum, plastic, plexiglass, fibreglass, pieces of map, a magazine, and two sponge mitts that were used as intake plugs.
